PRODUCT INFORMATION SHEET - V8 CYLINDER HEAD GASKETS

Part Numbers Applicable To:

UE31004 - UT12890PD - 07V103147

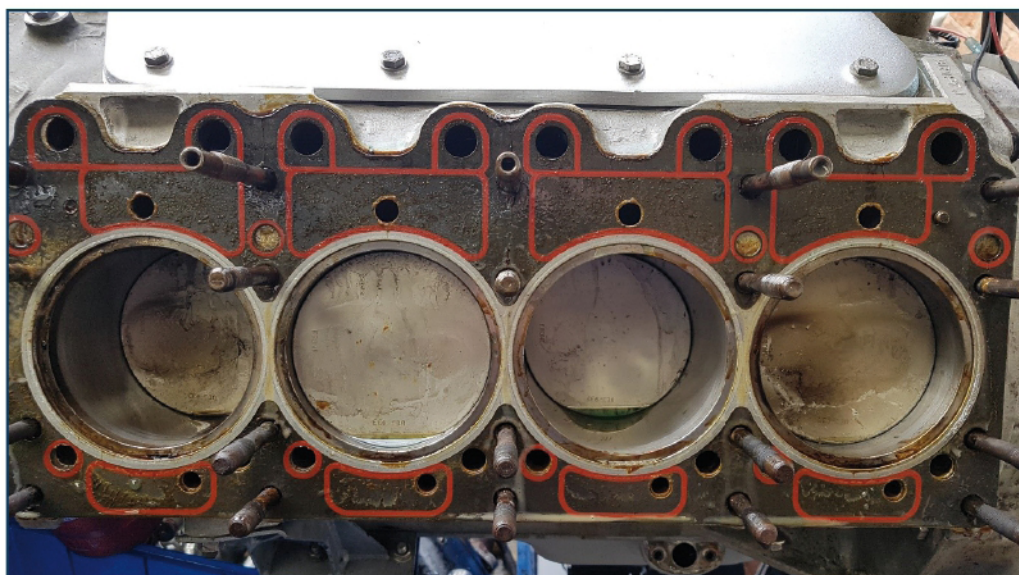
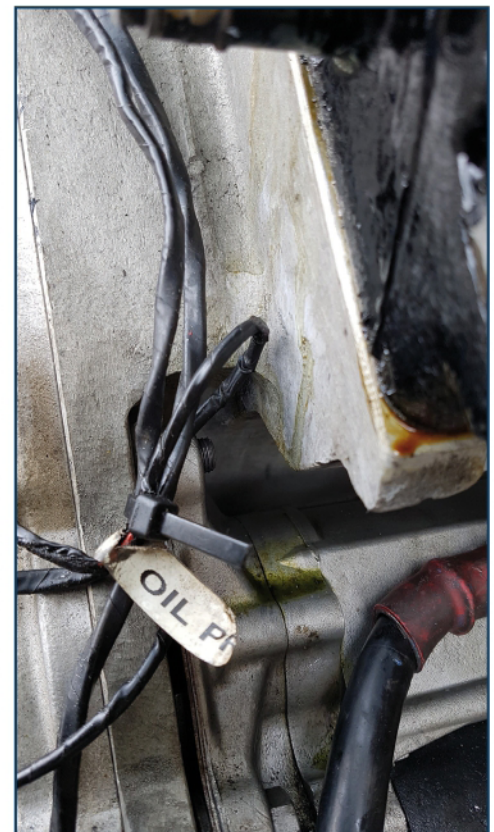
Since March 2019 we have become aware that some engines, having had the head gaskets replaced, have leaked externally and/or internally. We believe that it is the head gasket itself that is the cause of these failures. As part of our investigations into these failures we have been measuring batches of gaskets and recording the dimensions. This has led us to conclude that the most likely cause of the gasket failure is that the difference in height between the steel firing ring (the section around the top of the cylinder liner) and the composite material (that forms the principal part of the gasket) exceeds acceptable tolerances. Allied to this is a suspicion that the red silicone beading has not been correctly applied to the gasket.

Images show examples of both internal and external leaks.

We have regrettably removed these gaskets from sale as we are unable to offer any warranty on them.

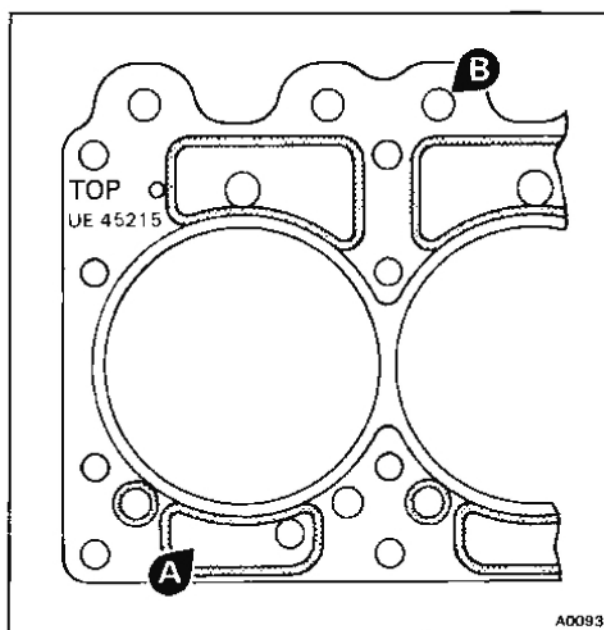
The new cylinder head gasket is similar to that used previously on the Bentley Mulsanne Turbo engine. However, changes have been made to the push rod hole size and one of the coolant hole passages has been deleted (see figs.1 and 3).

Fig 3 New Gasket Now Used on
ALL Engines (UE 45215)
A One hole has been deleted
B Push rod hole decreased
in size

The latest gasket (UE 45215) can be used for ALL Bentley Mulsanne Turbo engines, but MUST NOT be used on normally aspirated engines prior to vehicle identification numbers listed above. UE 31004 must be used on all these earlier engines.
