## PRODUCT INFORMATION SHEET - CYLINDER HEAD GASKETS

UE31004P - UT12890PD - 07V103147

All models from 1959 to 2004 with a V8 engine – see Appendix A

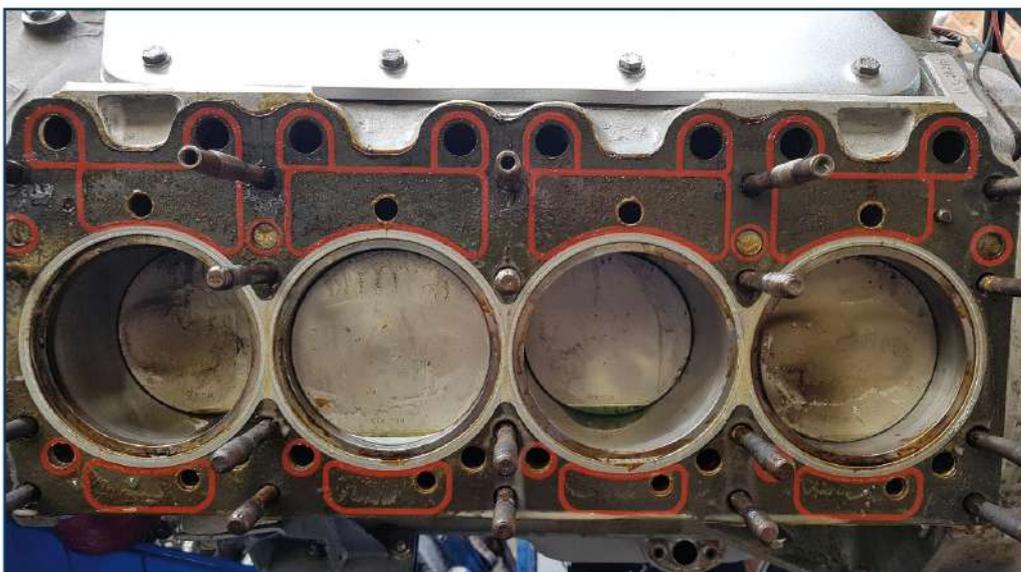
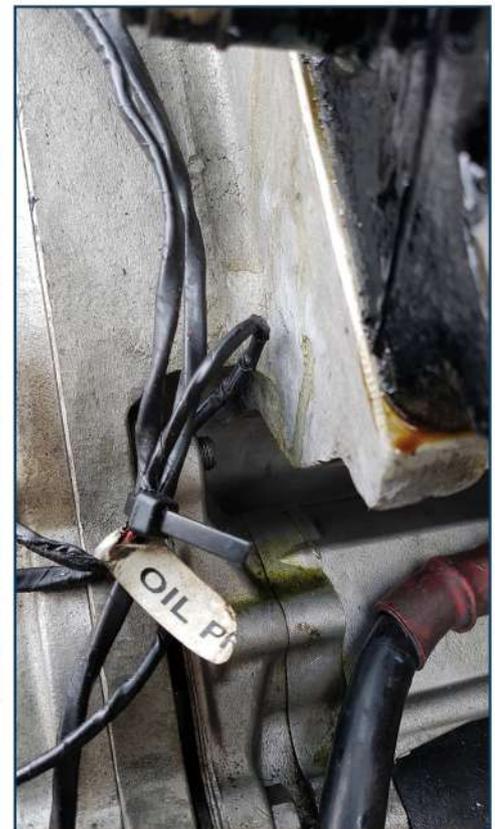
Since March 2019 we have become aware that some engines, having had the head gaskets replaced, have leaked externally and/or internally. We believe that it is the head gasket itself that is the cause of these failures.

As part of our investigations into these failures we have been measuring batches of gaskets and recording the dimensions. This has led us to conclude that the most likely cause of the gasket failure is that the difference in height between the steel firing ring (the section around the top of the cylinder liner) and the composite material (that forms the principal part of the gasket) exceeds acceptable tolerances. Allied to this is a suspicion that the red silicone beading has not been correctly applied to the gasket.

Images show examples of both internal and external leaks.

We have regrettably removed these gaskets from sale as we are unable to offer any warranty on them.

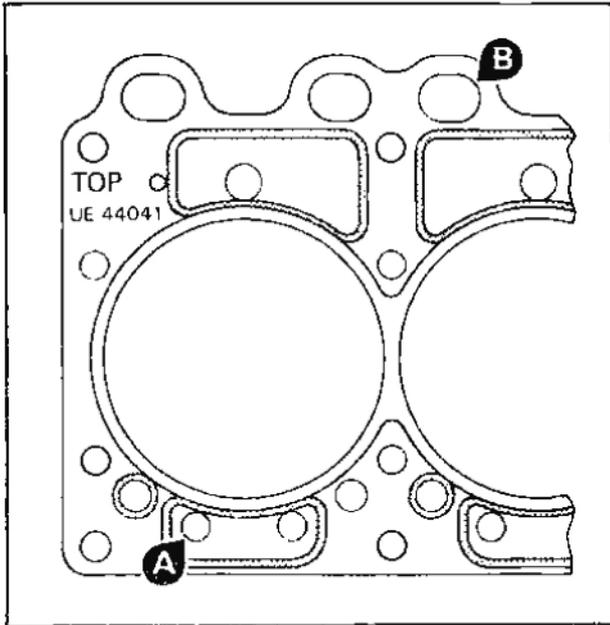
Fig 1 Early Bentley Mulsanne Turbo Gasket (UE 44041)

- A Two coolant passage holes
- B Size of push rod hole

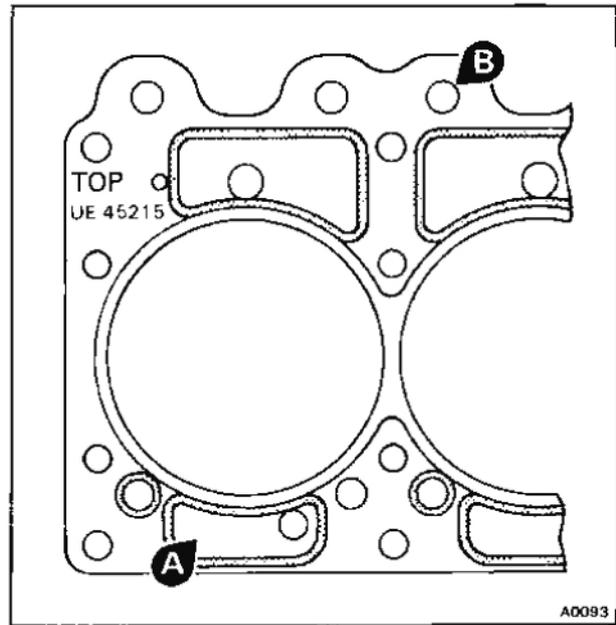
Fig 3 New Gasket Now Used on ALL Engines (UE 45215)

The new cylinder head gasket is similar to that used previously on the Bentley Mulsanne Turbo engine. However, changes have been made to the push rod hole size and one of the coolant hole passages has been deleted (see figs.1 and 3).

- A One hole has been deleted
- B Push rod hole decreased in size

The latest gasket (UE 45215) can be used for ALL Bentley Mulsanne Turbo engines, but MUST NOT be used on normally aspirated engines prior to vehicle identification numbers listed above. UE 31004 must be used on all these earlier engines.

The new gasket (UE 45215) should be assembled dry.
