Flying Spares

HYDRAULIC TAPPET (Valve lifter) - UV11163PAP INSTRUCTION SHEET UV11163PAPINS (Version 3 - November 2020)

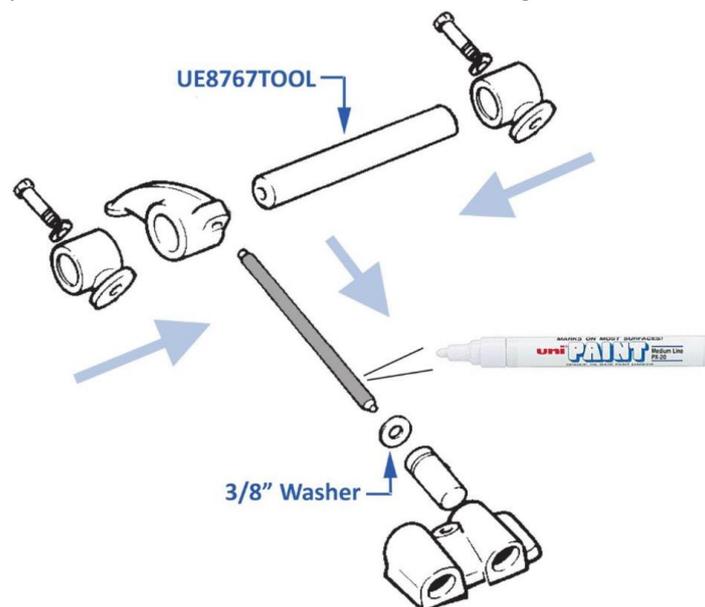
- 6) Mark the push rod with the white paint pen where the top of the washer and the push rod align. Make the marking wide enough so that you can scribe two lines in the white paint (say 6-8mm or 1/4-3/8”).

- 8) Scribe a first line in the white paint, where the top of the washer aligns with the push rod.
- 9) Release the tension on the tool by unscrewing the rocker pedestal screws.
- 10) Scribe a second mark in the white paint in line with the top of the washer.
- 11) Remove and repeat for the remaining 15 push rods and valve lifters.
- 12) Measure and record the gaps between the two lines on each of the 16 push rods using the Vernier scale.
