INSTRUCTIONS TO FIT REAR CRANKCASE SEAL MODIFICATION KIT (UE7488KIT)

ALL V8 ENGINE CARS FROM 1959 (SILVER CLOUD II & S2) THROUGH TO LATE SILVER SHADOW II & T2 MODELS (VIN 39529 APPROX)

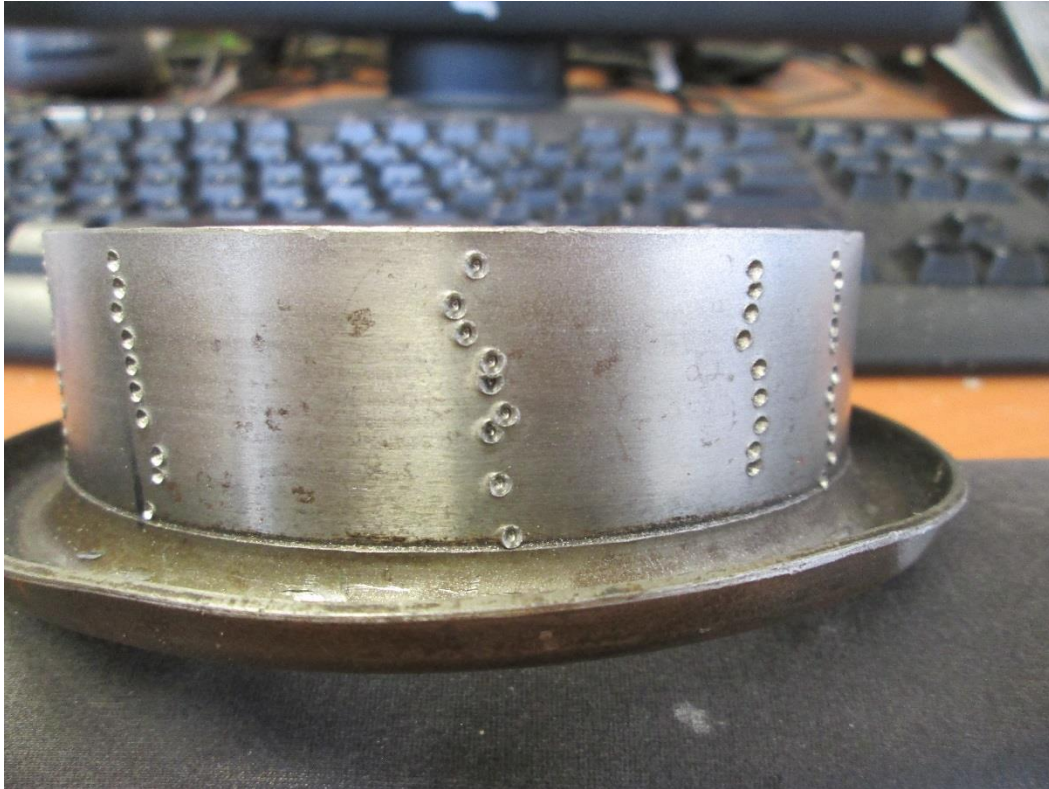
PHOTO: P1

To remove the flinger we recommend that you centre punch it in order to spread it, then gently lever it off - see photo P1.

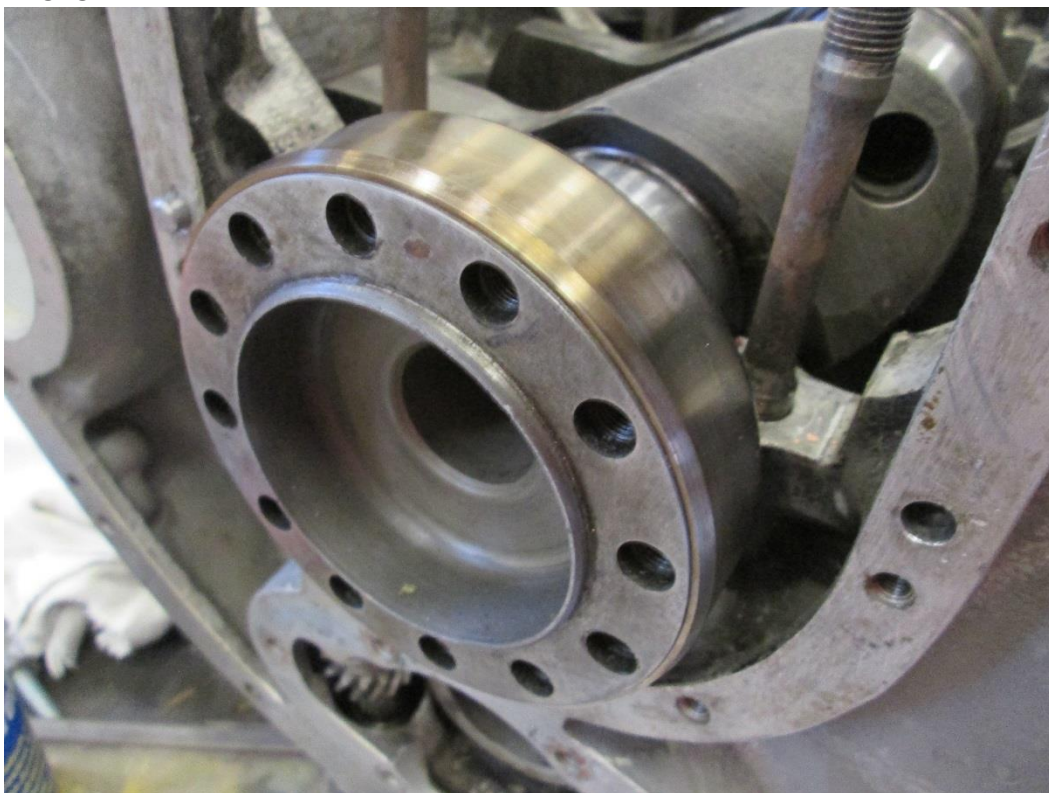
PHOTO: P2

To fit the new sleeve UE37777 we recommend gently heating the sleeve up until it just starts to turn brown (similar to heating a starter ring gear in order to fit it) and tapping it onto the crankshaft using the old flinger - see photo P2.

Do not allow the sleeve to get too hot as this will damage the case hardening.
