Flying Spares

DRIVESHAFT INFORMATION SHEET

CONVERSION TO MODIFIED BEARING RG8104P

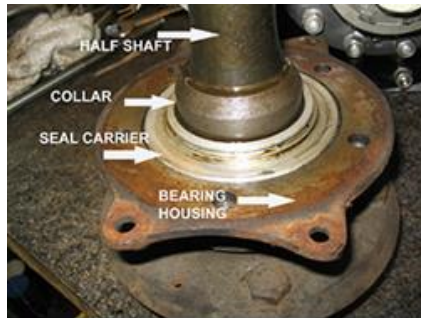
Fig1- old half shaft and bearing assembly after withdrawal from the axle tube

The various workshop manuals describe the removal of the half shaft assemblies, which are removed complete with bearings and bearing housings. Fig 1 shows a very old unit to illustrate what the assembly looks like after its removal from the axle.

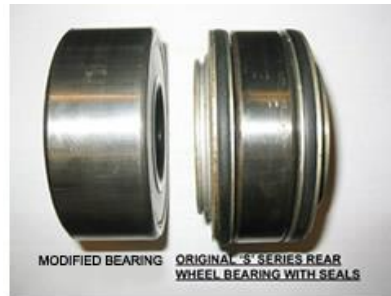
Fig 2 - A new modified bearing and an original S type bearing including oil seals

Fig 2, Fig 3 and Fig 4 show comparisons of the original and new bearings in various states of dress. Note in Fig 2 how the two original side oil seals and carriers make up the width of the old assembly to fit in the wheel bearing housing.

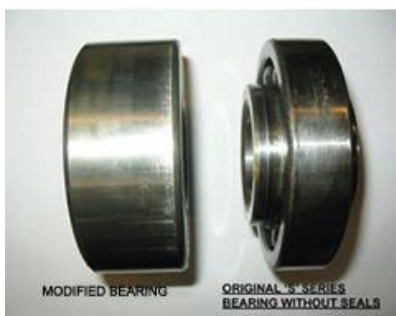
Fig 3 - A new modified bearing and an original S type bearing without oil seals.

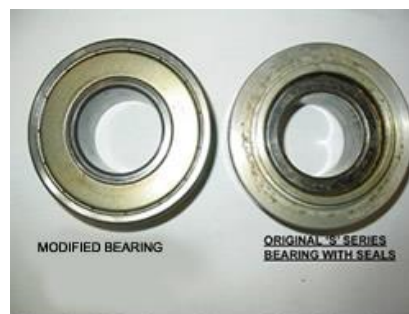
Fig 4 - Side view of a modified bearing and an original S type bearing including oil seals
