## **Instructions for fitting of modified rear wheel bearing RG5365P**

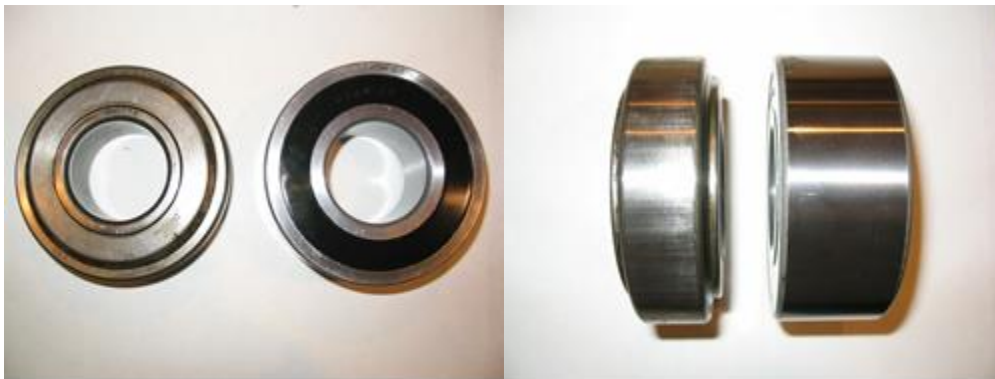
**Fig 1. Comparison of original and modified bearing, face view, the old bearing is on the left hand side.**

**Fig 2. Comparison of original and modified bearing, end view, the old bearing is on the left hand side.**

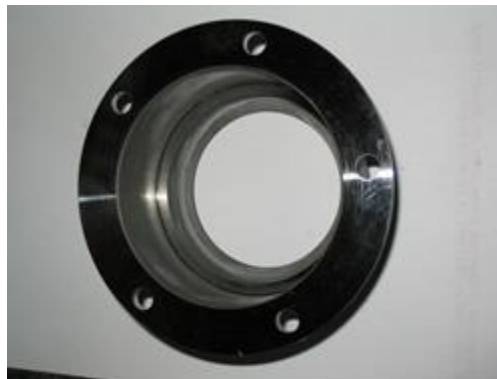
**Fig 3. wheel bearing housing after machining and the flange has been ground.**

The replacement bearing must not be allowed to end float within the bearing housing and will need a protrusion from the housing when the bearing is fitted of at least 0.001 inch. This amount allows a zero end load when the bearing housing flange has been covered in sealer and the assembly fitted to the axle. The various workshop manuals describe the removal of the half shaft assemblies, which

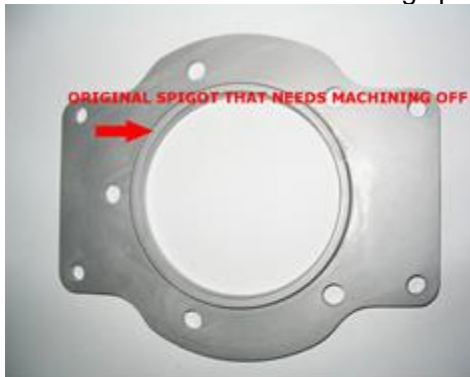
**Fig 4. Original bearing spigot plate, showing spigot lip.**

Next, examination of the bearing spigot plate will show a location protrusion or spigot, which needs machining off the plate and the plate face grinding to finish. This protrusion originally contacted the original bearing spacer ring, which has now been discarded, it should also be said that the protrusion did provide a spigot to assist in centralising the assembly. However the bearing housing attachment bolts and their holes are very accurate in size and circular pitch dimension, and therefore centralisation and the retention under load appears well catered for, even when the assistance of the spigot is lost. Note that it is necessary to dismantle the rear brake assembly to extract the bearing spigot plate!!

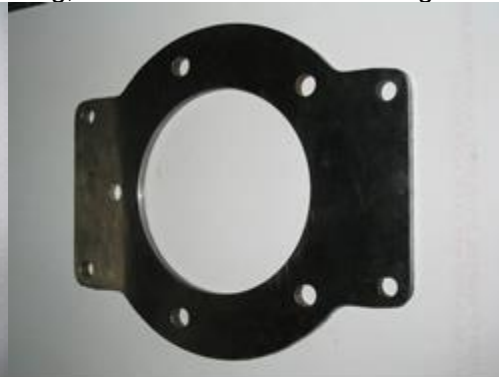
**Fig 5. Spigot plate after the lip has been face ground off.**

First undo the four nuts, bolts and spacers holding the bearing retaining plate to the brake carrier. Do not fail to collect the spacers. Now you will see the bearing spigot plate which has a protrusion on its inner face, this needs machining off and the plate just face-grinding on BOTH sides to clean it up and is discussed later. Note that this spigot plate has a taper lead on the opposite face to that face with the protrusion this taper face goes towards the axle.

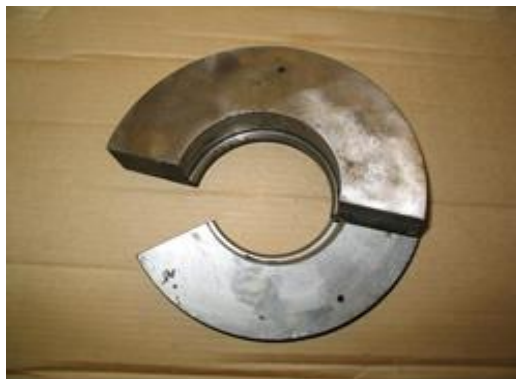
**Fig 5. blocks to hold the bearing housing during pressing operations.**

At this point it is necessary to mount the shaft in a hollow hydraulic press bed and provide a suitable support for the bearing housing whilst the shaft is pressed through, and therefore off the bearing. My own supports are made of a steel circular section some 9 inches in diameter and 1.250 inch thick.

This circular section was then machined to fit around the bearing housing with an integral step, this step was lathe-turned to fit the step in the bearing housing and then finally the circular section was sawn across the centre. This tool then forms two "U" shaped sections, which completely surround and support the bearing housing whilst the pressing operation is in progress.

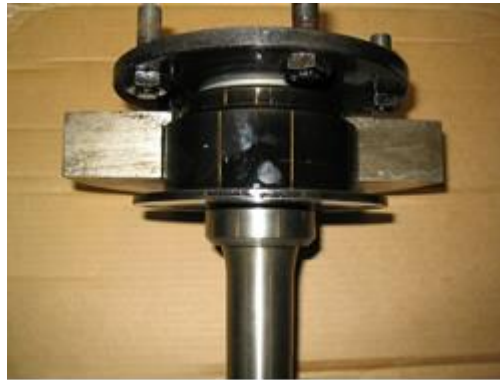
**Fig 9. Supporting block showing how the block lip embraces the bearing housing.**

It is very important that the flange of the bearing housing, which is about 0.125 inch thick, is not used to support the housing during pressing operations. The bearing housing STEP must take the load and if any load is applied to the flange, distortion and subsequent water entry will result. There is also a very serious possibility of the flange breaking away at some time in the future.

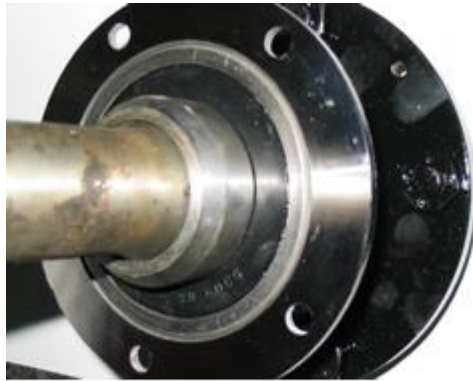
**Fig 10. Showing a finished assembly  
note how the new bearing fully  
fills the bearing housing.**
