PRODUCT INFORMATION SHEET

Hydraulic Seals operating in RR363 Brake Fluid

All Silver Shadow & Bentley T models including Series II, 2 Door MPW & LWB, Corniche & Camargue models (prior to VIN 50001)

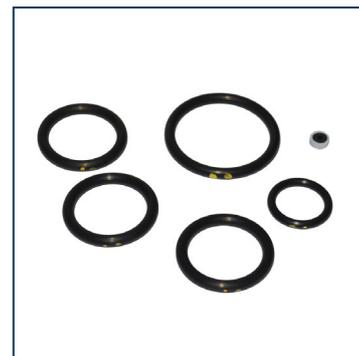
RH2435P

Each of our O rings is uniquely identified by two yellow dots for easy identification.

Accumulator Valve Body Seal Kit
