PRODUCT INFORMATION SHEET - V8 CYLINDER HEAD GASKETS

Part Numbers Applicable To:

UE31004 - UT12890PD - 07V103147

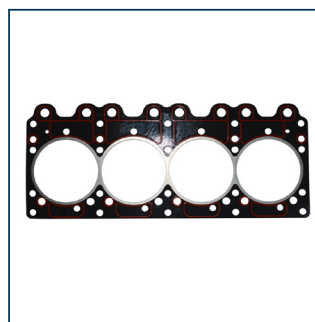
07V103147

In 2015 customers started to report failures of the OE (Original Equipment/ Genuine Bentley) cylinder head gaskets (07V103147 – which are stamped with the previous part number UT12890PD) which we felt were caused by blistering of the red bead on the gasket which allowed coolant to bypass the gasket.

In 2019 further failures were reported of the OE cylinder head gaskets (07V103147) with engines which were leaking immediately after the head gaskets had been replaced.

As previously stated, we have experienced several failures of the OE cylinder head gaskets (07V103147) in our workshops, as have many of our customers. Understandably, we now deem that the OE cylinder head gasket (07V103147) is no longer fit for purpose.

Therefore, we strongly advised against fitting the OE gasket (07V103147) and recommended our replacement aftermarket gasket UE31004P.

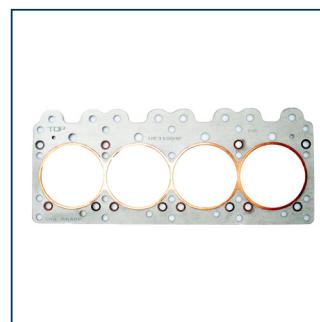
C) Previous failures caused by insufficient or inadequate beading on 07V103147 have been overcome by not using this type of beading on UE31004P.

At the time of writing (April 2022) we have sold over 500 of our re-designed UE31004P gaskets and experienced no failures whatsoever.
