# Flying Spares

## **FITTING INFORMATION**

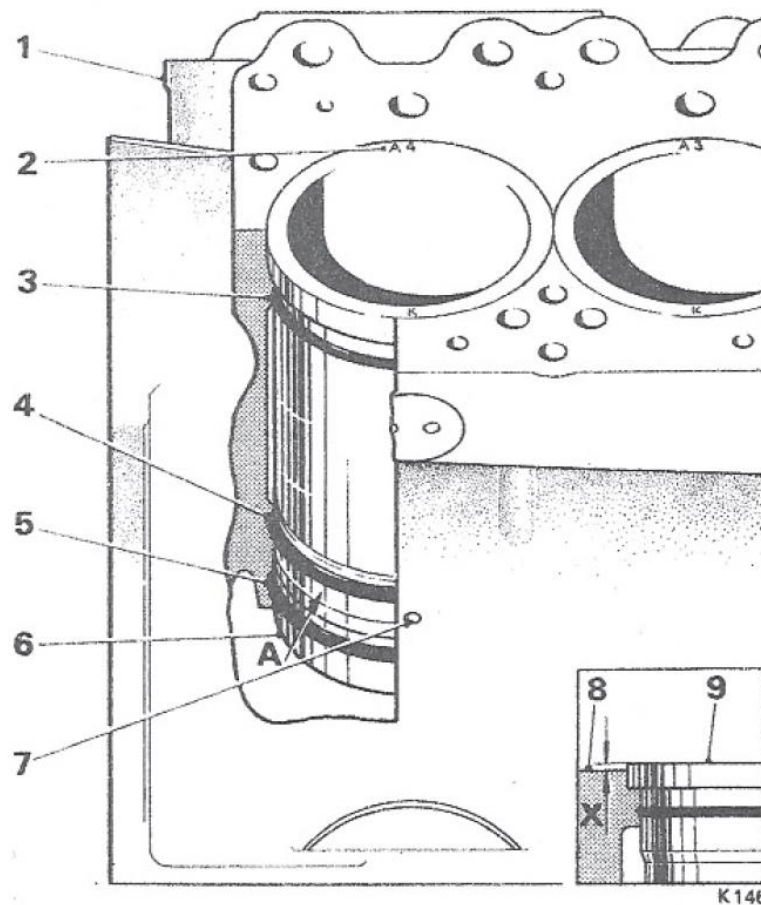
**FIG .E20 CYLINDER LINER IN CRANKCASE**

**A** Position of corrosion build up on cylinder liner and crankcase  
**X** 0,051mm. to 0,076mm. (0.002 in. to 0.003in.)

- 1** Crankcase
- 2** Bore reference number
- 3** Rubber 'O' ring
- 4** Upper sealing ring
- 5** Lower sealing ring
- 6** Cylinder liner
- 7** Tell tale hole (8 off)
- 8** Crankcase
- 9** Cylinder Head

Cylinder liner seal leakage can be detected by 'tell-tale' holes in the side of the crankcase. Coolant or oil will issue from these holes depending upon which of the two bottom scaling rings is leaking. The upper of the two bottom rings leaks coolant and the lower one leaks oil, in either case the appropriate liner should be removed, and new seals fitted to the crankcase (see Fig. E20).
