PRODUCT INFORMATION SHEET - CYLINDER HEAD GASKETS

UE31004P - UT12890PD - 07V103147

All models from 1959 to 2004 with a V8 engine – see Appendix A

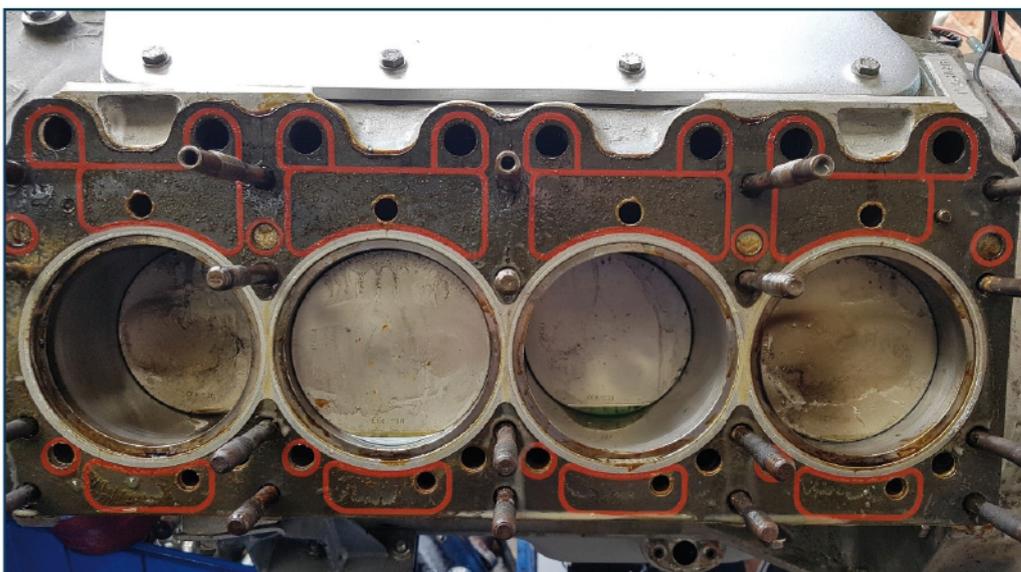
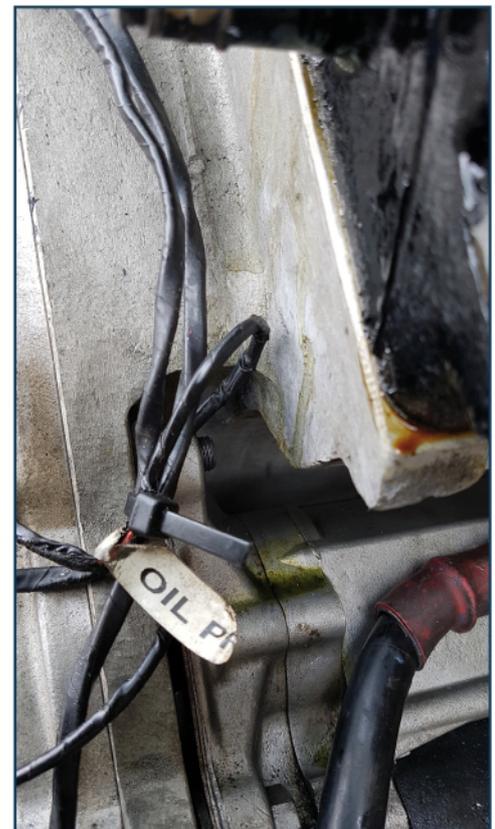
Since March 2019 we have become aware that some engines, having had the head gaskets replaced, have leaked externally and/or internally. We believe that it is the head gasket itself that is the cause of these failures.

As part of our investigations into these failures we have been measuring batches of gaskets and recording the dimensions. This has led us to conclude that the most likely cause of the gasket failure is that the difference in height between the steel firing ring (the section around the top of the cylinder liner) and the composite material (that forms the principal part of the gasket) exceeds acceptable tolerances. Allied to this is a suspicion that the red silicone beading has not been correctly applied to the gasket.

Images show examples of both internal and external leaks.

We have regrettably removed these gaskets from sale as we are unable to offer any warranty on them.

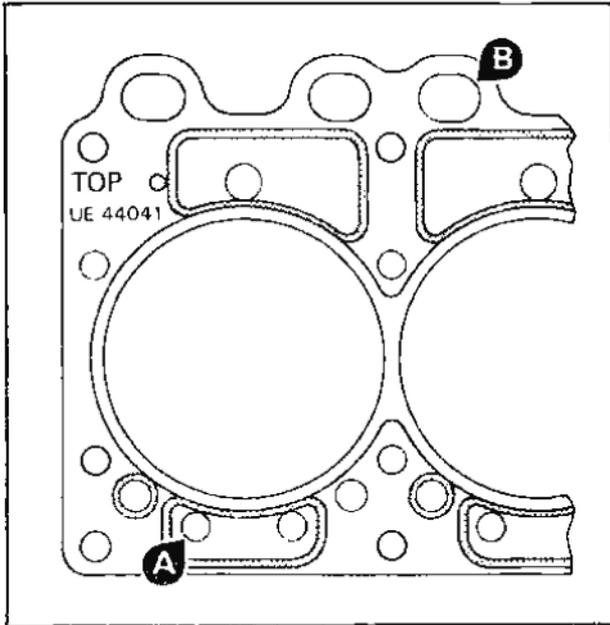
Fig 1 Early Bentley Mulsanne
Turbo Gasket (UE 44041)
A Two coolant passage holes
B Size of push rod hole

The new cylinder head gasket is similar to that used previously on the Bentley Mulsanne Turbo engine. However, changes have been made to the push rod hole size and one of the coolant hole passages has been deleted (see figs.1 and 3).

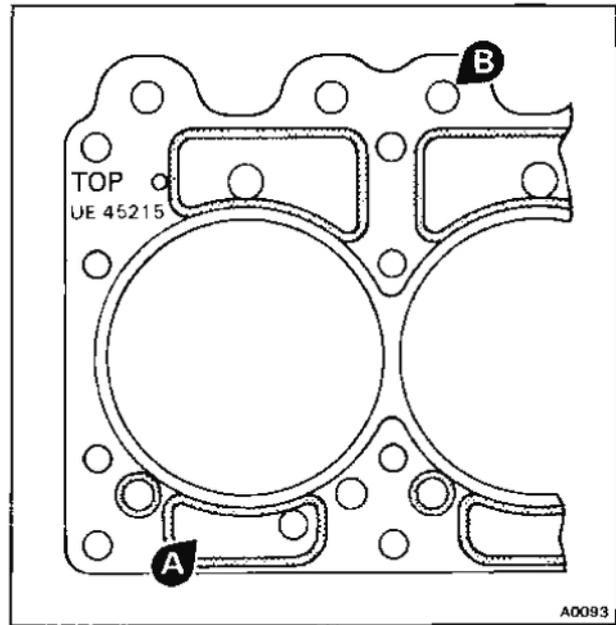
Fig 3 New Gasket Now Used on
ALL Engines (UE 45215)
A One hole has been deleted
B Push rod hole decreased
in size

The latest gasket (UE 45215) can be used for ALL Bentley Mulsanne Turbo engines, but MUST NOT be used on normally aspirated engines prior to vehicle identification numbers listed above. UE 31004 must be used on all these earlier engines.

The new gasket (UE 45215) should be assembled dry.
